SAMPLE REPORT · PRE-PURCHASE BUILDING INSPECTION

Detached house on three floors with partial basement, pool and garden; occupied

Bradley Cahill · Antipodean Building Services  
Lda

AP-2026-R-SAMPLE

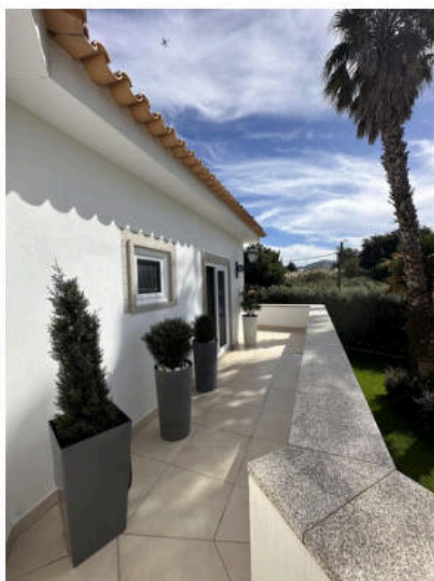
| OBSERVED | <p>Large-format tiles laid to the veranda with skirting tiles at the wall. The roof eave above projects over part of the veranda only; there is no gutter, and on the open part the roof discharges straight onto the tiles. The granite capping on the brick parapet wall has wide open joints between stones, with no sealant in them. Grout lines in the tiles are worn and open in places. The drainage outlets at the wall are partly blocked with debris and have no grilles. The seals around the window and door frames where they meet the granite sills and reveals are aged and gapped. At the base of the wall the render is damaged in one spot behind the skirting.</p> <p>Moisture readings were elevated at points along the wall base behind the bedrooms and normal elsewhere. Water appears to pool on the veranda along this wall.</p> |
| WHY IT MATTERS | Water on the veranda has three ways in: through the open capping joints into the parapet wall, through the open grout into the bed and the slab below, and through the frame joints into the reveals. Because the veranda does not drain freely, water sits against the wall and the frames for longer than it should. The result is the damage at the far bedroom in 6.2 and the blistering inside in 6.3. Left as it is, the timber will continue to decay and the lime finish will keep failing at the same points. The structure is not at risk. |

Fig. 6.1a — Veranda with the roof eave above; no gutter, and the open section takes the run-off.

Fit a gutter to the eave above the veranda with downpipes into the site drainage, as part of the whole-house rainwater system in 6.5. Rake out the capping joints, insert a backer rod and seal with a UV-stable polyurethane or MS polymer joint sealant coloured to the granite; where a capping stone is loose or its bed is open, lift it, apply a liquid waterproofing membrane over the wall head and rebed it on a flexible adhesive. Rake out the tile grout and regrout in a two-part epoxy grout, with sealed movement joints at the perimeter and over any slab joint. Clear the outlets, check the falls run to them, and fit stainless grilles. Cut out the old frame seals and reseal all window and door perimeters with a low-modulus sealant over backer rod. Water test the veranda before the internal repairs start.

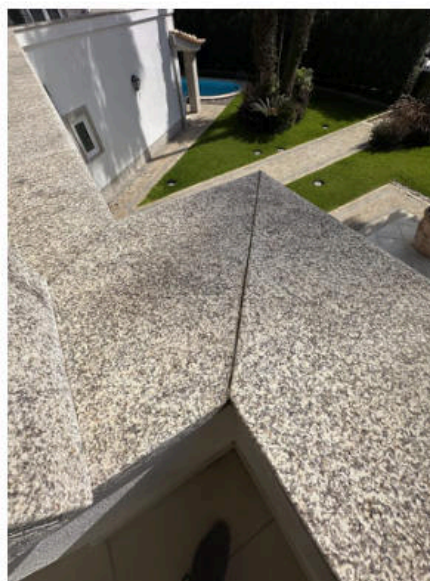
Fig. 6.1b — Granite capping on the parapet wall with an open joint between stones.

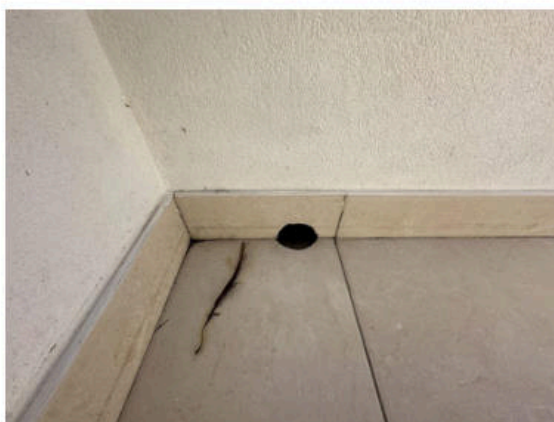
Fig. 6.1c — Drainage outlet at the wall, partly blocked with debris.

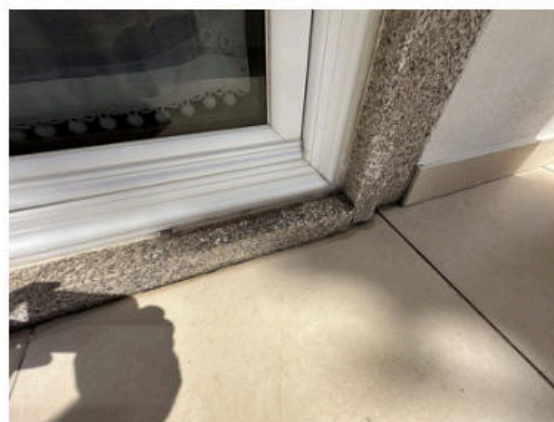
Fig. 6.1d — Frame and granite sill junction onto the veranda; seal aged and gapped.

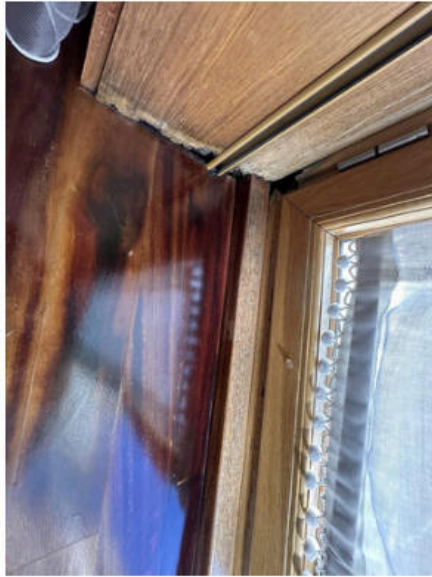
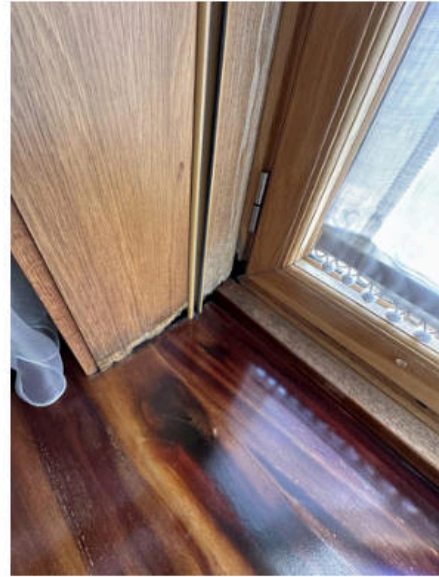
| OBSERVED | Varnished timber door with a double-glazed panel, opening onto the veranda. The bottom rail of the leaf and the foot of the frame are weathered, open-grained and soft in appearance, with the finish broken down. Inside, the hardwood floorboards at the threshold are darkened with water staining, consistent with water passing under the door and through the frame joint over a period. |
| WHY IT MATTERS | Decay at the foot of a timber frame spreads upward if the frame stays wet, and the joint between frame and sill is now letting water through to the floor. The floor damage is local. The door itself appears otherwise sound. |

Fig. 6.2a — Foot of the door frame and leaf: weathered, open-grained timber; stained boards inside.

Fig. 6.2b — Same door, hinge side; the floor stain runs from the frame joint.

| WHAT TO DO | Once the veranda works in 6.1 are done, cut out the decayed timber at the foot of the frame and leaf and splice in matching hardwood with an epoxy repair system, or replace the leaf if the decay runs further than it appears. Refinish with a microporous exterior finish, fit new compression seals and a threshold with a drip, and bed the frame foot on sealant. Lift the stained floorboards, check the subfloor is dry, replace the boards with matching stock, and sand and refinish to blend. |

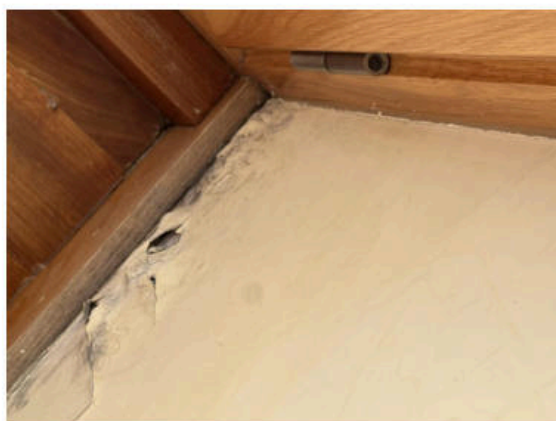
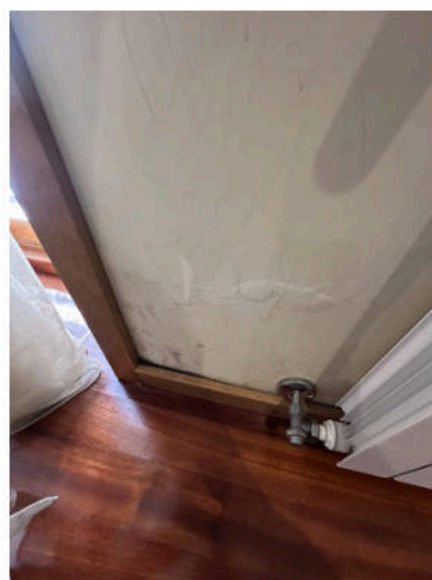
The internal walls are finished in a polished lime plaster of the stucco or marmorino type, which appears to have been sealed with a wax or varnish. At the window reveal the finish has blistered and split along the timber lining, with dark staining. On the bedroom wall beside the door frame the finish has lifted in raised blisters at low to mid height, next to the radiator valve. Elsewhere the finish is in good condition.

Moisture readings were elevated at the blistered areas and normal elsewhere.

Lime is vapour-open and copes with some moisture, but a sealed surface does not. When water reaches the plaster from behind, it carries salts towards the face and pushes the sealed skin off as blisters, often with a white powder behind. The blisters are the symptom. At the window reveal the likely source is the frame seal in 6.1. Beside the radiator the cause could be the same wall moisture or a weep from the heating pipework in the wall, and that needs ruling out first.

Fig. 6.3a — Window reveal: blistered and split lime finish along the timber lining.

Fig. 6.3b — Bedroom wall beside the door frame and radiator valve: raised blisters in the finish.

Stop each source first. Pressure test the heating circuit and check the radiator valve and tails beside the blistered wall before assuming it is the veranda. Once the veranda and frame seals are done, let the walls dry out for several weeks and confirm with a meter. Then scrape the blisters back to sound plaster, brush off the salts, consolidate, fill and build up in lime putty, apply the finish coats and burnish. Seal with a natural wax or lime soap only; an acrylic varnish over lime is likely to cause the same failure again. Repair to a natural break such as a corner, so the patch does not show. This is work for a specialist stuccatore.

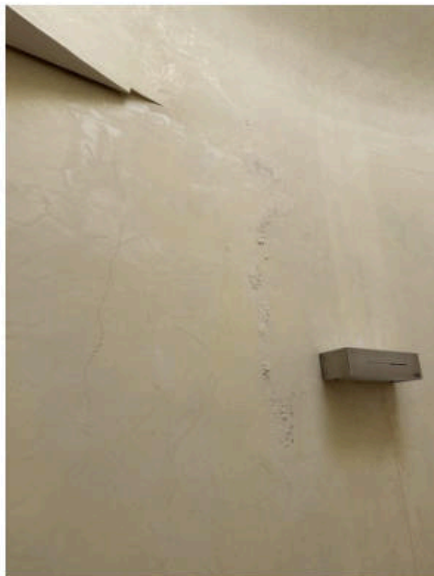
A spiral timber stair with stainless balustrade inside a rendered round tower, lit by a rooflight at the top. On the inside face of the tower a vertical line of blistering runs down the polished lime finish, with white powdery salts along it, close to a wall light. Fine map cracking is visible in the finish nearby. From outside the tower is rendered in the capoto system and capped with tiles; the upper part and the rooflight could not be seen closely from the ground.

| WHY IT MATTERS | A straight vertical line of blistering with salts usually means water is tracking down a fine crack or a joint, either in the external render, at a board joint in the insulation system, or from the rooflight upstand. It is minor now. The tower is the most exposed part of the house and it is worth finding the path before the winter. |

Fig. 6.4a — Inside the stair tower: vertical line of blistering with white salts in the lime finish.

| WHAT TO DO | Inspect the tower render and the rooflight from an access platform or by drone. Map any cracking in the render and check the rooflight upstand and flashing. Repair cracks in the capoto by opening, embedding reinforcing mesh in a base coat, and refinishing and repainting to match; reseal the rooflight flashing. Repair the inside face in lime as in 6.3 once dry. |

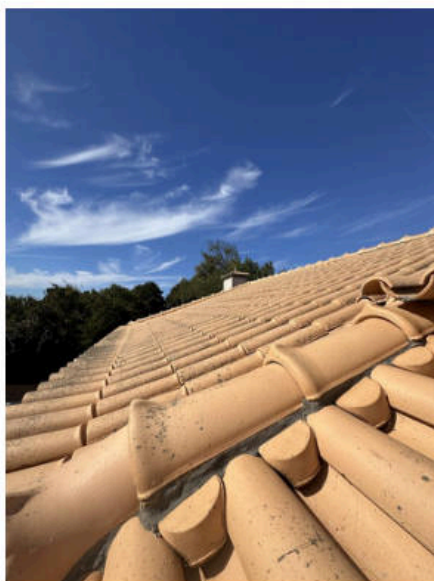
| OBSERVED | Pitched roofs covered in clay tile, in good condition with no slipped or broken tiles seen. The tiles carry scattered lichen spots. The mortar bedding the ridge and hip tiles is weathered, cracked and open in places. The eaves are traditional tiled eaves with no gutters or downpipes on any elevation, so the roofs discharge directly onto the terraces, the veranda and the ground. Two chimney stacks rise through the roof; see 6.7. |

Cracked ridge mortar lets wind-driven rain under the ridge and loosens the ridge tiles over time. Without gutters, the full roof catchment lands at the base of the walls and on the veranda, which is the root of the problem in 6.1. The covering itself is sound.

Fig. 6.5a — Ridge tiles: weathered and cracked bedding mortar, lichen on the tiles.

From one access set-up, rake out loose ridge and hip mortar and rebed or repoint in a lime mortar; where ridge tiles are loose, rebed over a ventilated ridge roll. Treat the tiles with a biocide and leave it to weather off; do not pressure wash. Install gutters to all eaves on brackets fixed under the first tile course or to a fascia, with downpipes at the corners connected to the existing site drainage. Aluminium in a colour to suit, or zinc, will match the house. Fit leaf guards where the palms overhang.

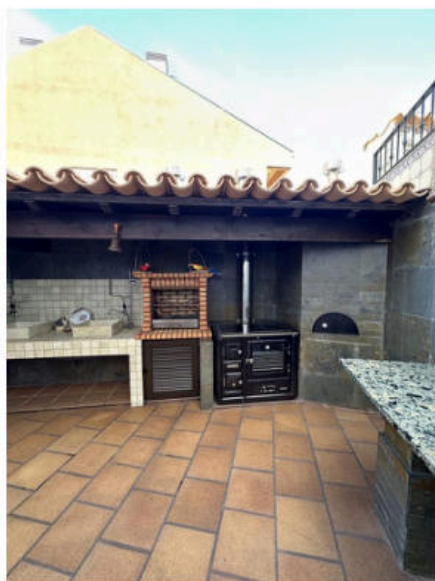
Fig. 6.6a — Barbecue kitchen with wood-fired oven and range, apparently unused.

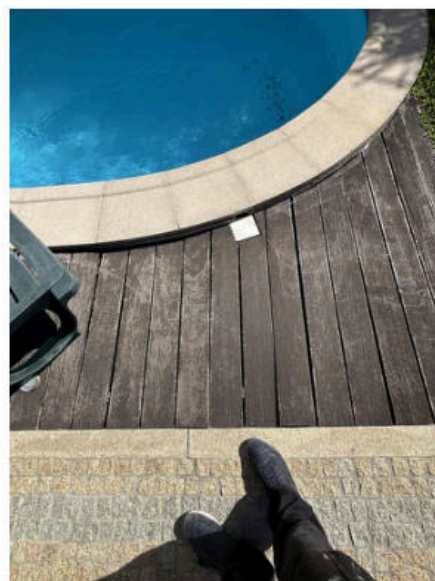
| OBSERVED | The barbecue kitchen has a tiled timber roof structure on masonry, a brick barbecue, a wood-fired oven, a cast-iron range and a stone worktop. The cooking equipment appears new and unused. Some of the pergola timbers show minor rot. The pool is surrounded by a hardwood deck that is grey and worn, with fixings standing proud in places. |
| WHY IT MATTERS | Both are maintenance items. Rot in the pergola will spread to sound timber if left, and an unfixed deck board is a trip hazard round a pool. |

Fig. 6.6b — Pool deck: grey and worn, fixings due.

| WHAT TO DO | Replace the decayed pergola members like for like, treat all timber with a preservative and restrain. Clean the deck, replace the fixings in A4 stainless screws, refix any loose boards, lightly sand and apply two coats of a penetrating deck oil; repeat the oil every year or two. |

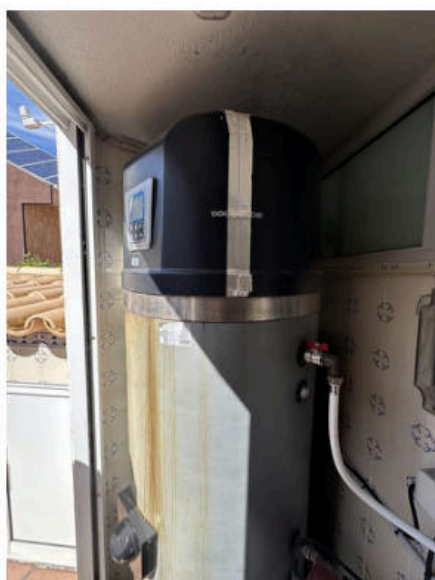
| OBSERVED | Domestic hot water is from a heat-pump cylinder in the outbuilding. Rust-coloured streaks run down the casing from the top section. The house has two fireplaces with inserts, in the living room and the basement games room. One chimney stack shows dark biological staining on its render. |

Streaking on a cylinder casing usually comes from a weep at a fitting, condensate from the heat pump section, or the casing itself corroding; it needs tracing before it becomes a leak. The stack staining is cosmetic.

Fig. 6.7a — Heat-pump hot water cylinder: rust streaks down the casing.

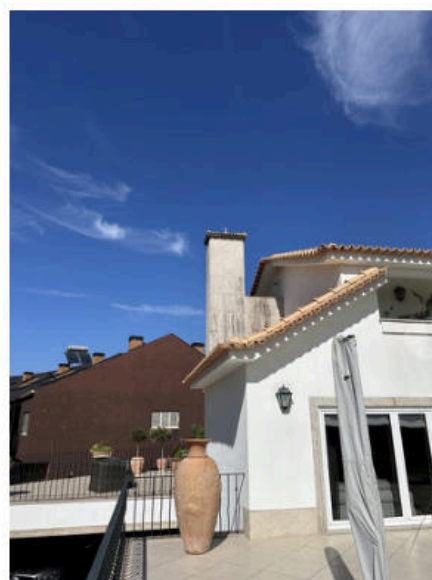
Fig. 6.7b — Chimney stack with staining on the render.
