SAMPLE REPORT · PRE-PURCHASE BUILDING INSPECTION

Detached house on three floors with partial basement, pool and garden; occupied

Bradley Cahill · Antipodean Building Services  
Lda

AP-2026-R-SAMPLE

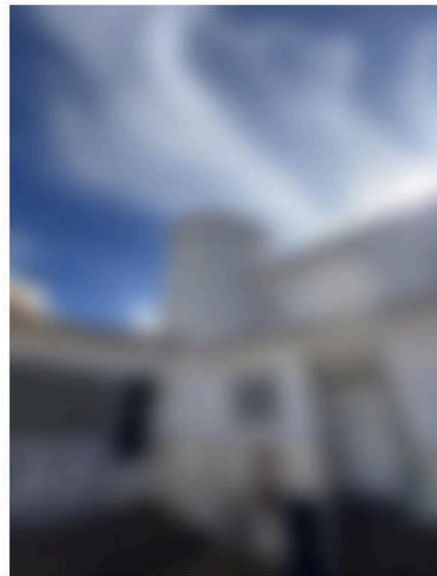
| ISSUE | RISK | IN SHORT | ACTION |
|---|---|---|---|
| Stair tower | MEDIUM | Line of blistering and salts in the lime finish; possible fine crack | Inspect the tower and rooflight from outside; repair; refinish |

Fig. 6.4b — The stair tower from the rear courtyard, rising above the roof line. Blurred for this sample.

| ITEM | LOW | HIGH | NOTES |
|---|---|---|---|
| Stair tower: inspection of the render and rooflight from an access platform, crack repair in the capoto system, rooflight flashing reseal | € 1,500 | € 4,000 | Provisional; scope set by the inspection |

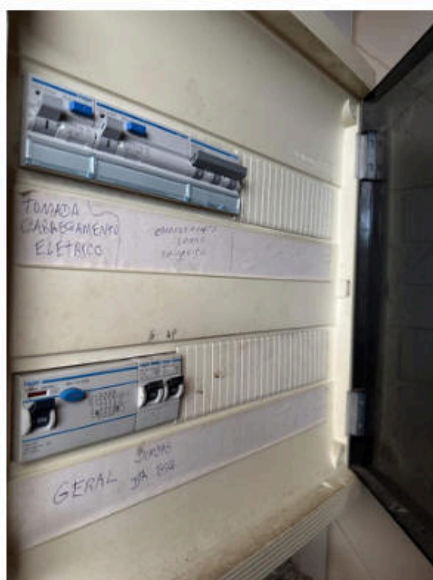
Fig. 8a — Garage board: the three-phase car charging circuit.

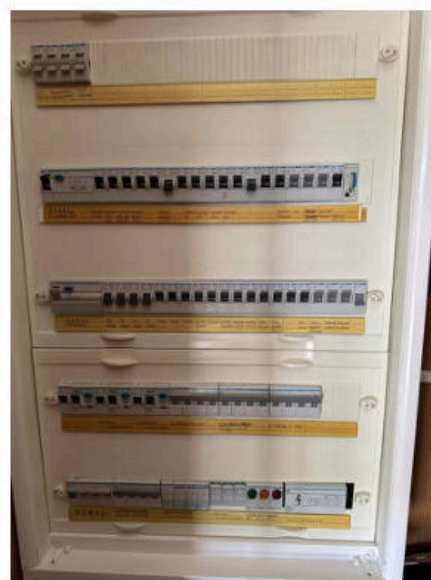
Fig. 8b — Main distribution board: labelled circuits with RCD protection.

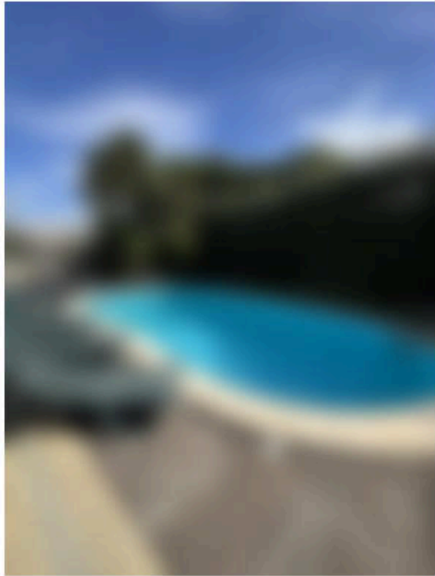
| ISSUE | RISK | IN SHORT | ACTION |
|---|---|---|---|
| Pool deck | LOW | Worn and grey; fixings due | Clean, re-screw in stainless, oil |

Fig. 9b — Pool with timber deck; the pool runs on well water and is unheated. Blurred for this sample.
